Manhole Inspection Summary

Manhole # S41MM_010MH

Location Address: **2040 HARFORD RD** Cross Street: **BONAPARTE AVE**

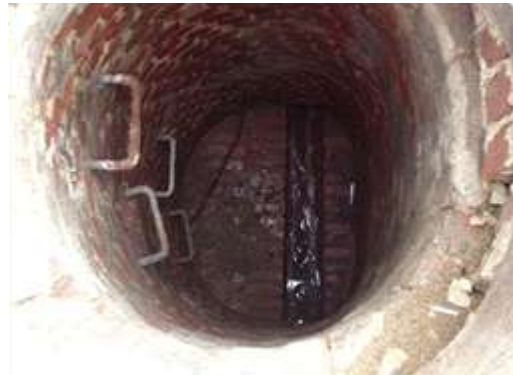
Top View

Corroded steps. Evidence of surcharge - Bench debris.

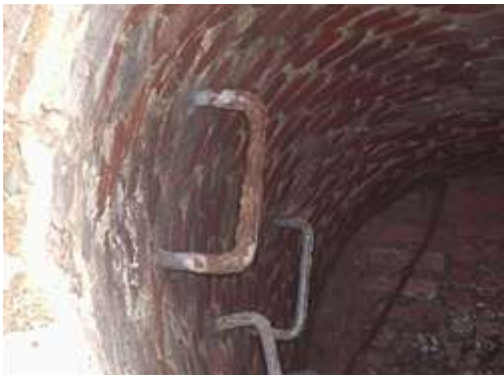
Defect

Corbel and Barrel infiltration.

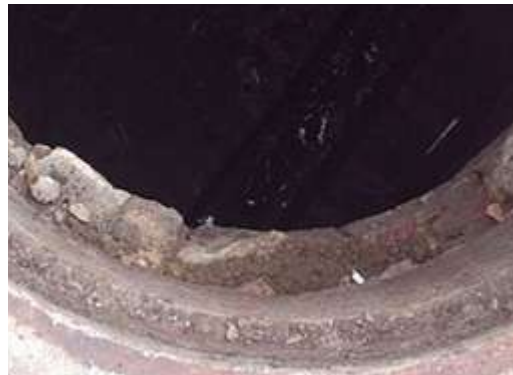
Defect

Frame leaks. Frame offset. Adjustment deterioration and infiltration.

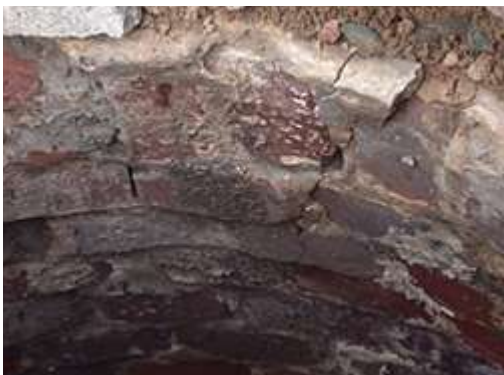
Defect

Adjustment deterioration, loose brick and infiltration. Corbel deterioration, cracks and infiltration.

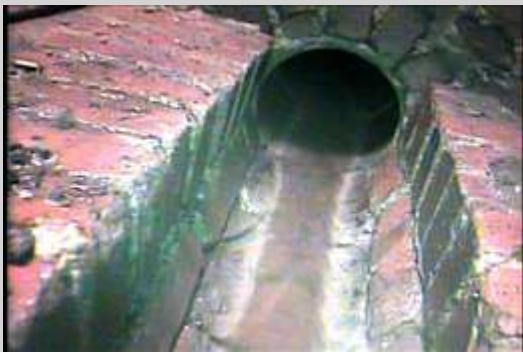
Pipe Out @ 12 O'Clock

Barrel deterioration and infiltration. Channel deterioration.

Deposits: ☐ None ☐ Mud ☐ Sludge ☐ Debris ☒ Grease

Infiltration: **None** Pipe Seal Cond: **Cracked**

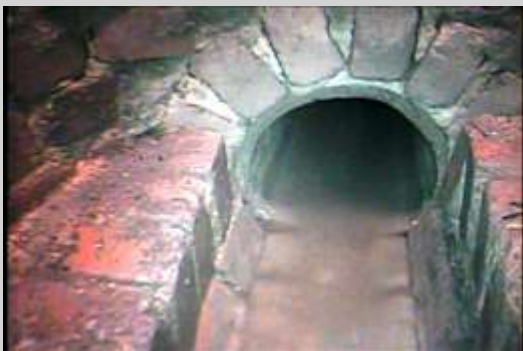
Pipe In @ 6 O'Clock

Infiltration: **None** Pipe Seal Cond: **Unknown**
